Rimkus Consulting Group, Inc.
Eight Greenway Plaza, Suite 500
Houston, TX 77046
(800) 580-3228 Telephone
(713) 623-4357 Facsimile

Re: RCG File No: 11009971
LLV Number: 0209452
VMF Location: 1530 Greensmark Drive in Houston, Texas
Subject: Final Report

Rimkus Consulting Group, Inc. was retained to examine LLV 0209452, VIN 1GBCS10E4M2908832. The fire occurred on June 13, 2016 at around 12:30 P.M. the operator of the vehicle at the time of the fire, was unavailable for interview but reportedly stated the vehicle's engine died while delivering mail on his route and backfired during subsequent attempts to restart it. Soon thereafter, smoke was observed from beneath the hood as well as flames.

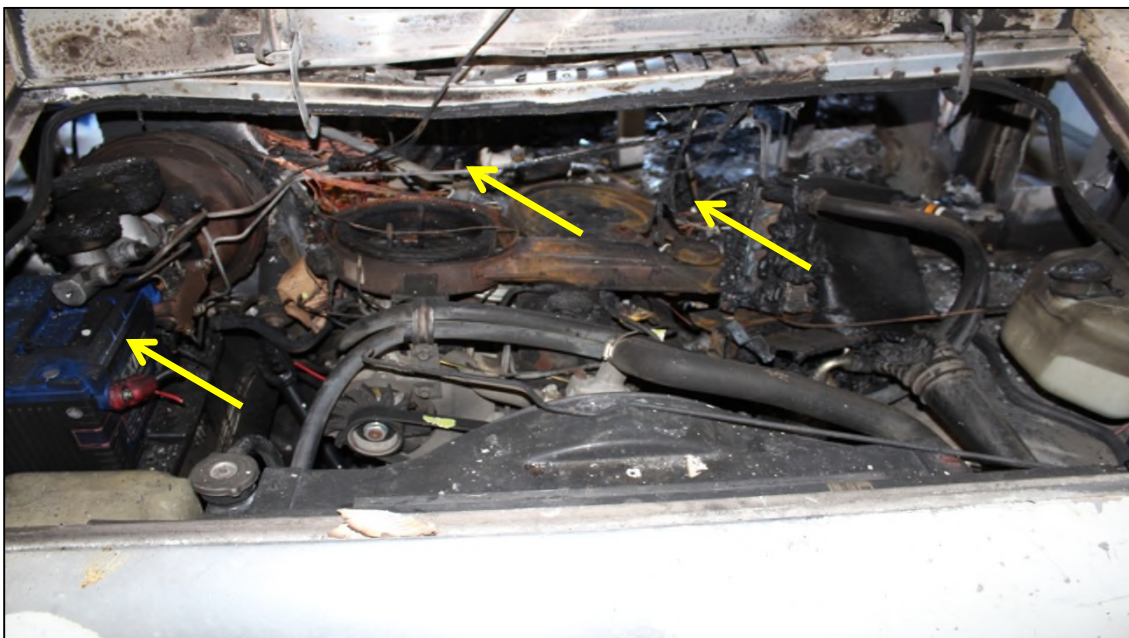
Photograph 6

Observe the severe fire damage to the rear area of the engine compartment and minor damage only to the battery area.

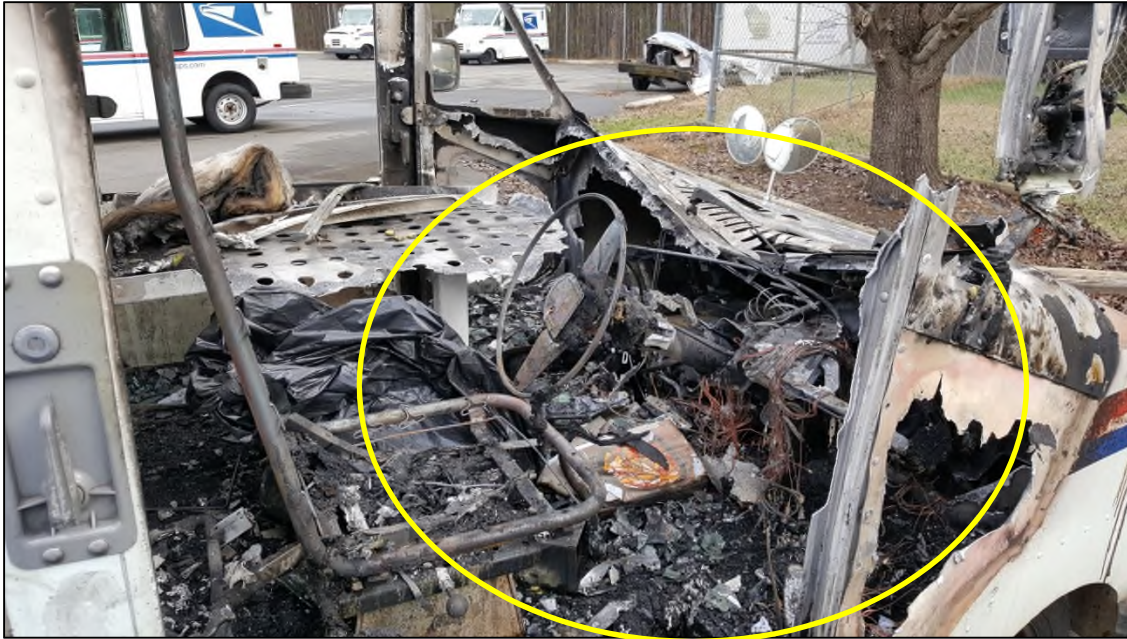
Photograph 7

Observe the severe fire damage to the driver's side dashboard area.

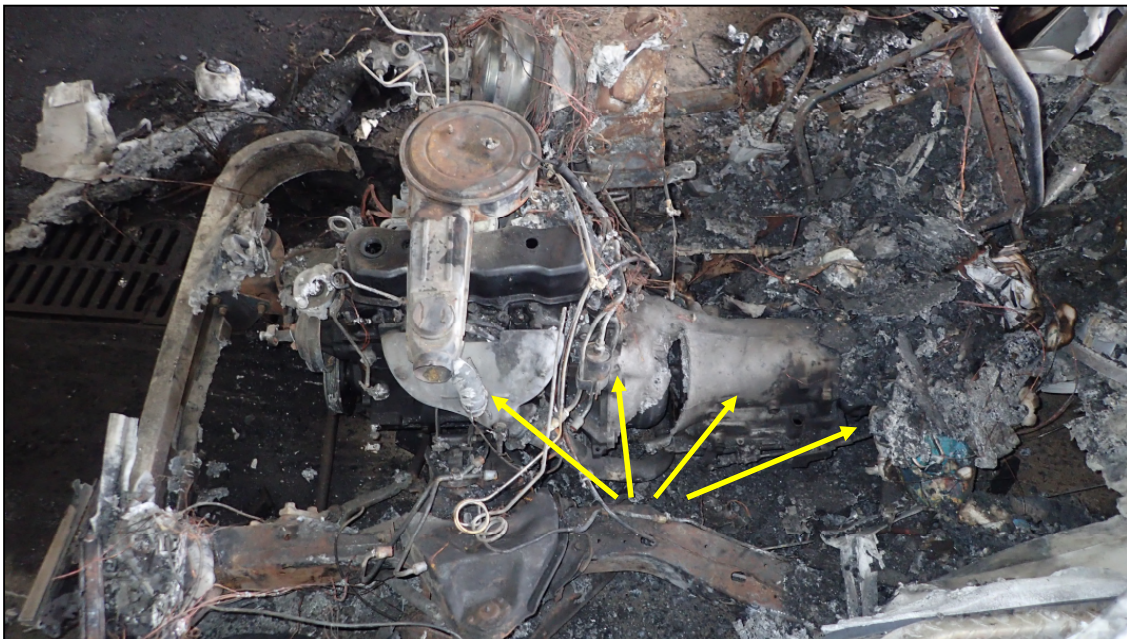
Photograph 2

View of the fire movement patterns in the engine compartment.

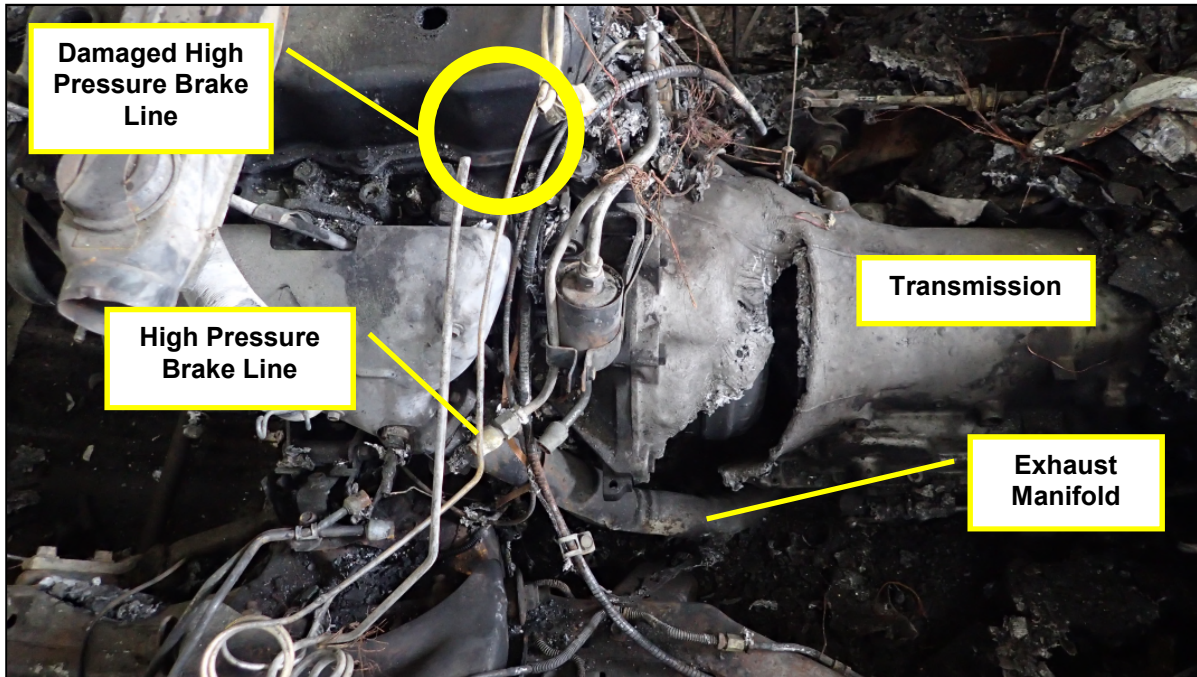
Photograph 3

View of the damaged high pressure brake line and fire damage to the transmission.

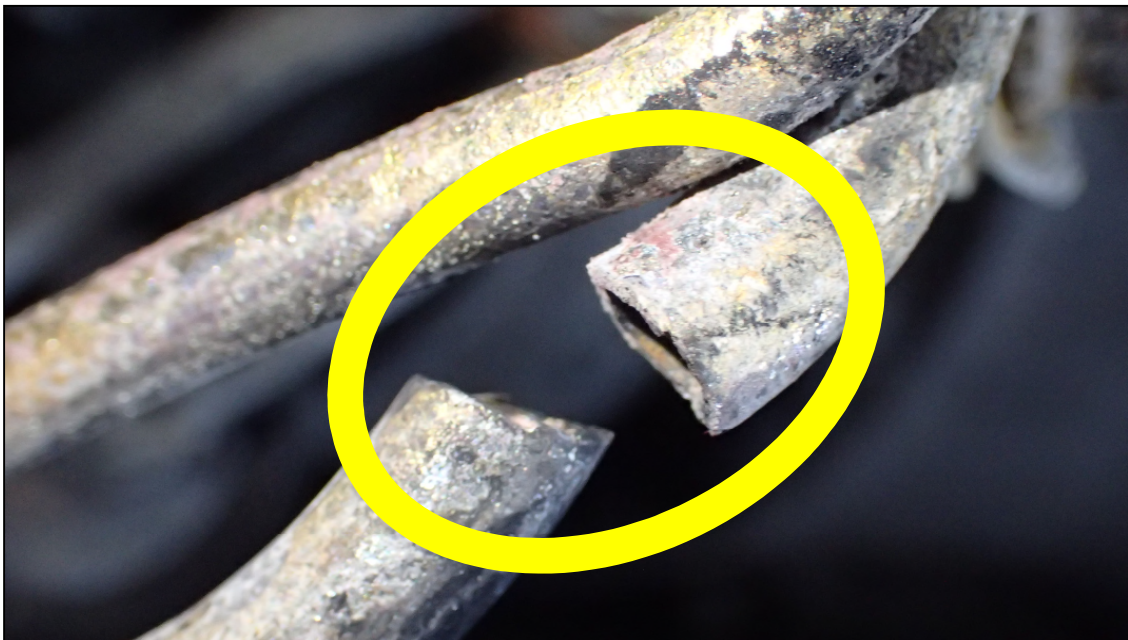
Photograph 4

View of the damaged high pressure brake line.

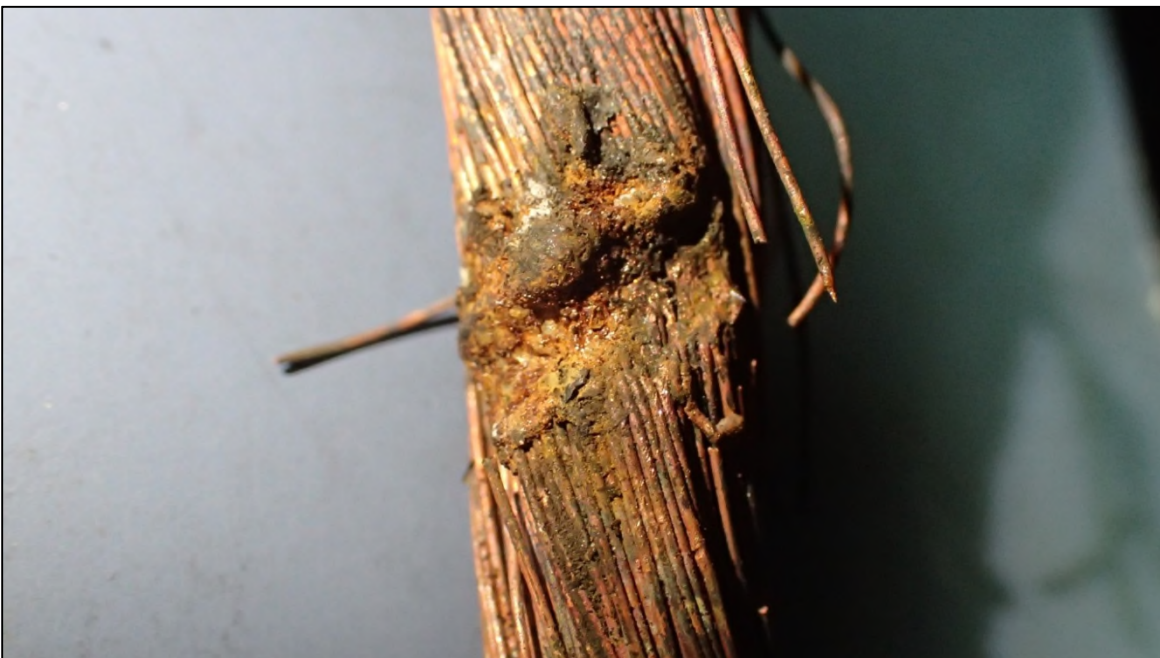
Photograph 6

A closer view of the adverse electrical activity to the battery cable.

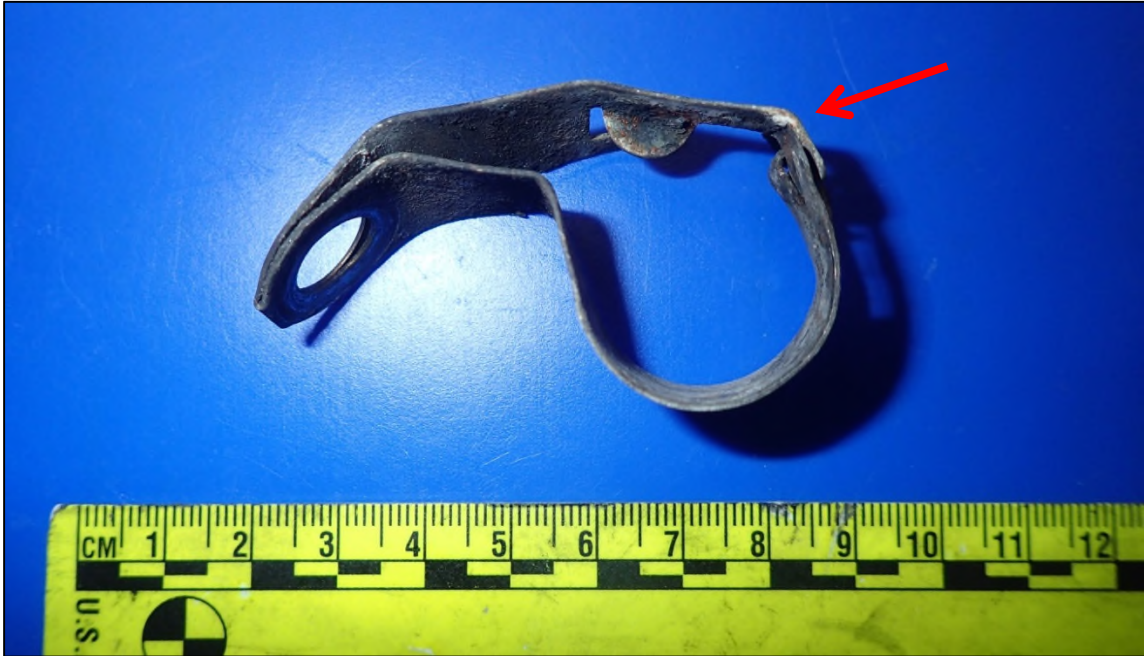
Photograph 7

The P-clamp, observe the damage to the clamp.

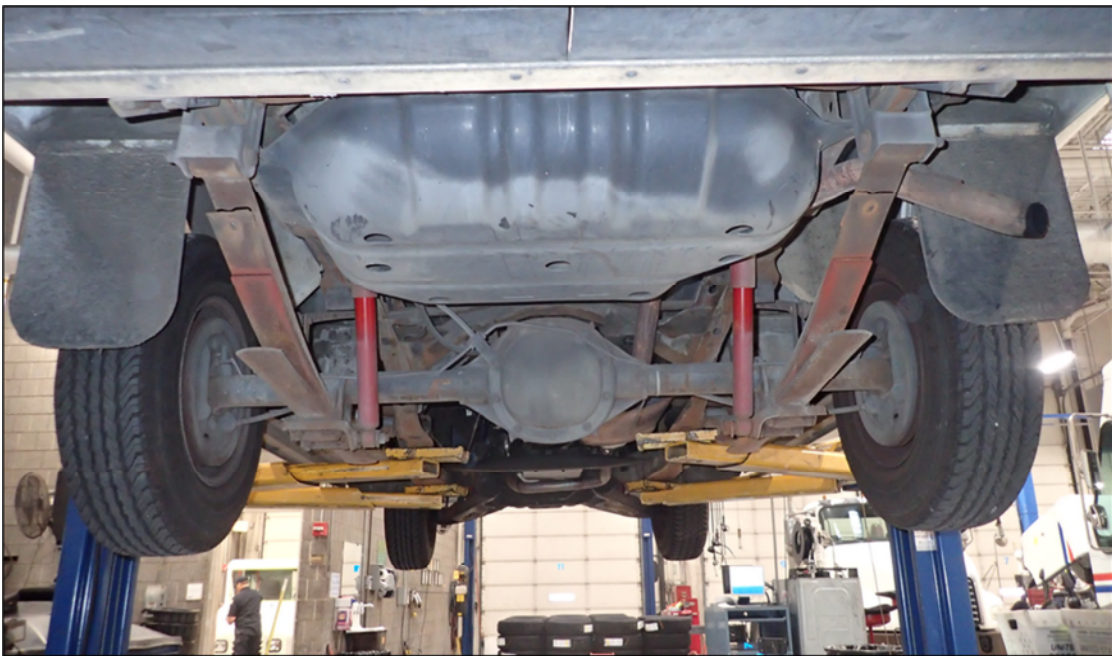
Photograph 8

The undercarriage, no fire damage observed.

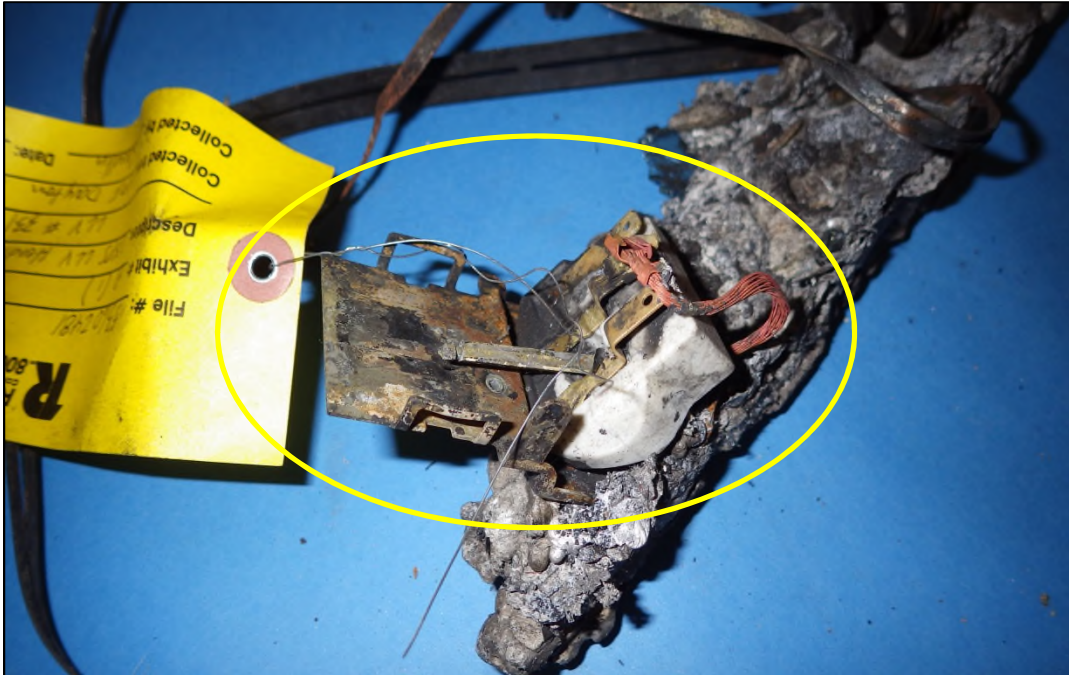
Photograph 5

A view of the remains of the headlamp Rheostat Switch during the lab exam.

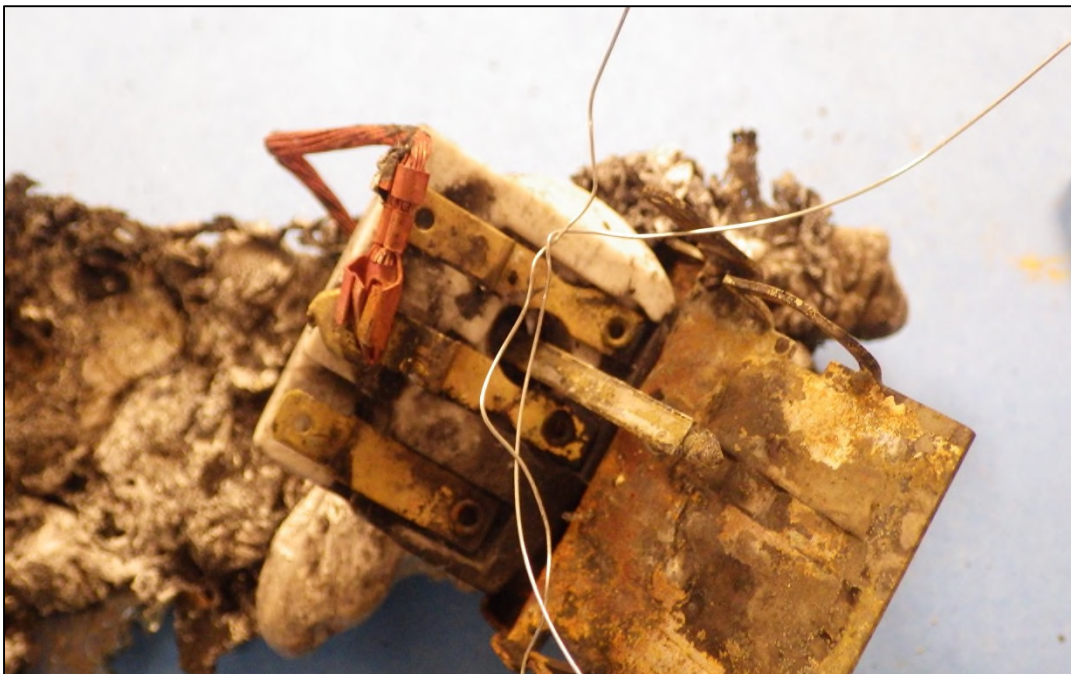
Photograph 6

The wiring harness terminal assembly, observe the severe fire damage and mass loss.

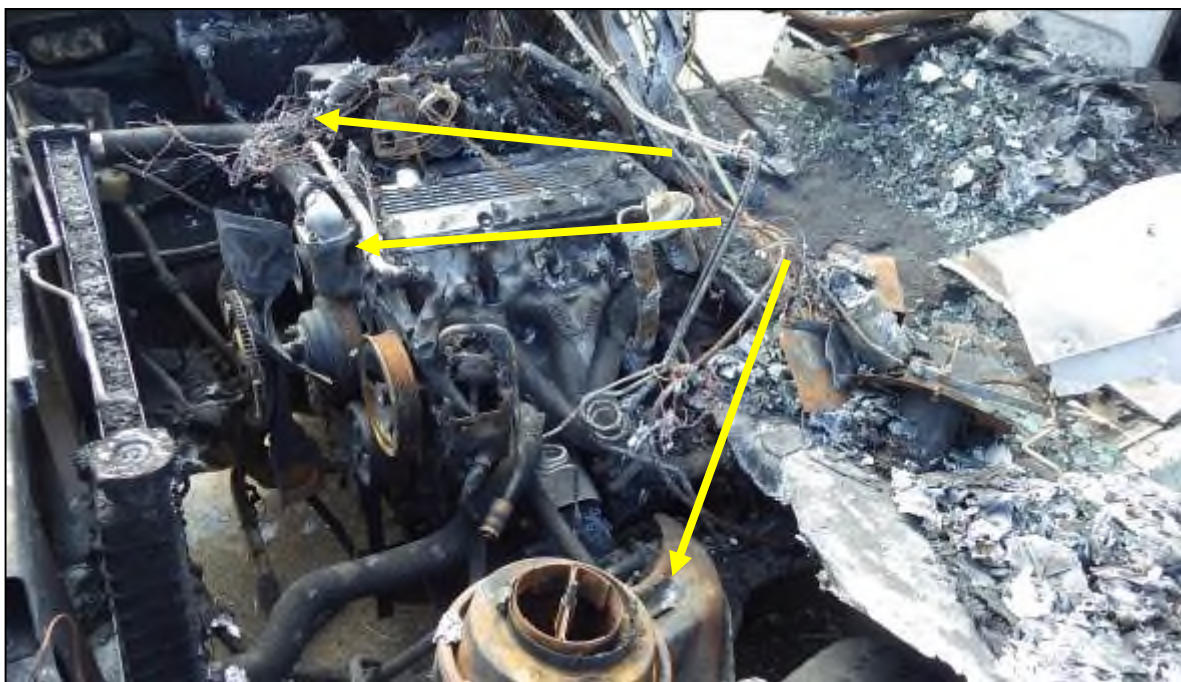
Photograph 4

View of the fire patterns and fire damage in the engine compartment.

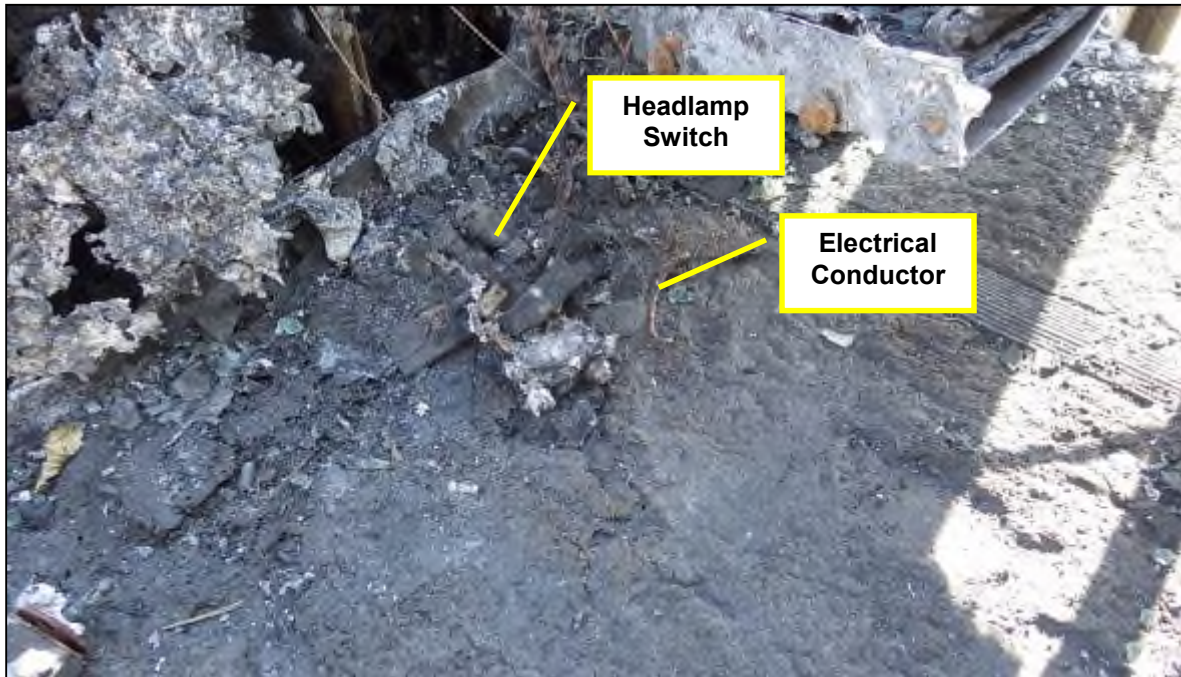
Photograph 5

View of the burned headlamp switch and electrical conductor.

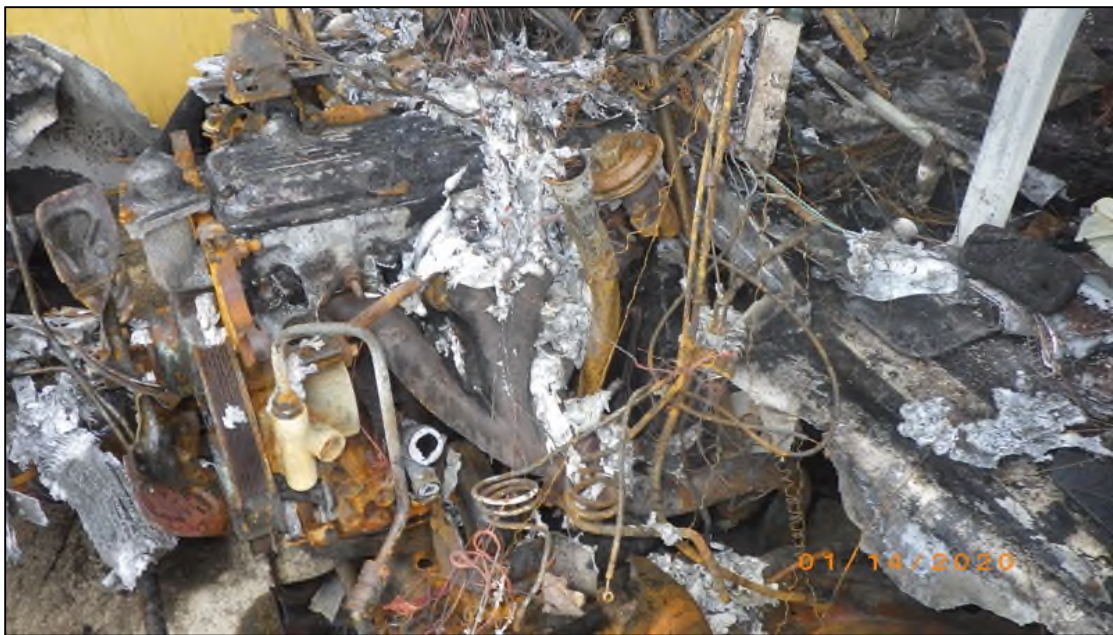
Photograph 16
A view of the power steering pump and stained exhaust manifold.

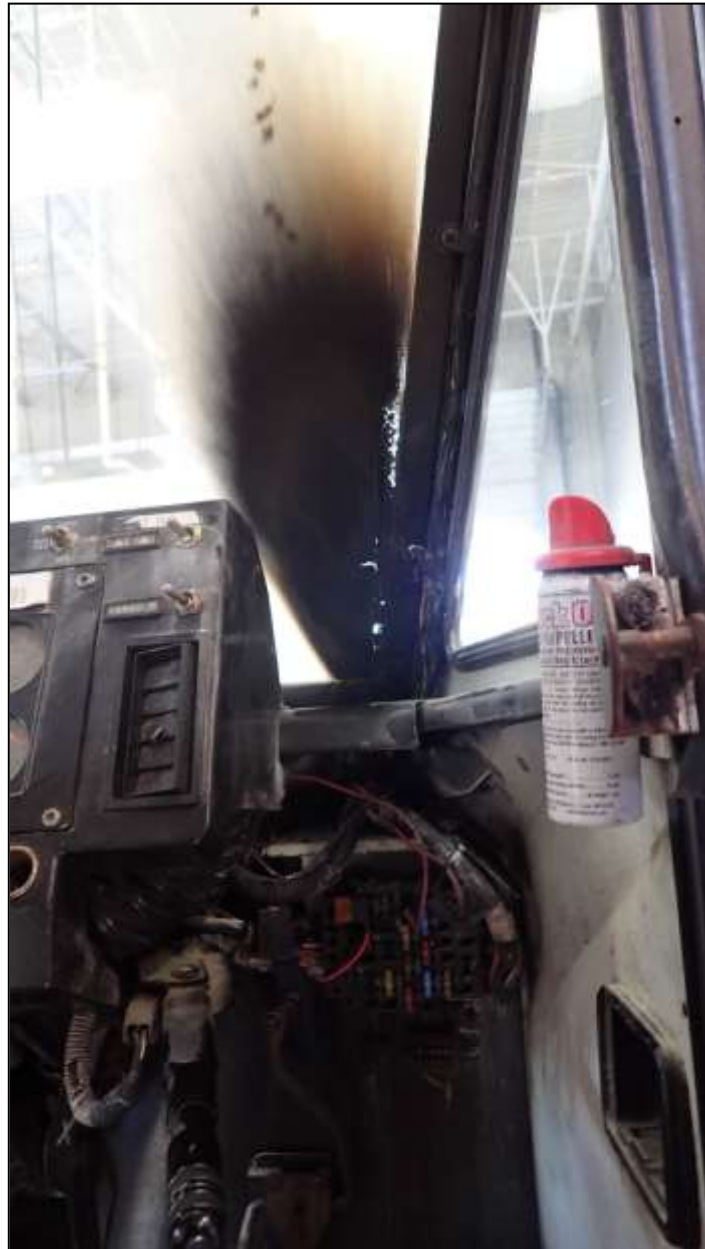
Photograph 3

View of the interior fire movement patterns.

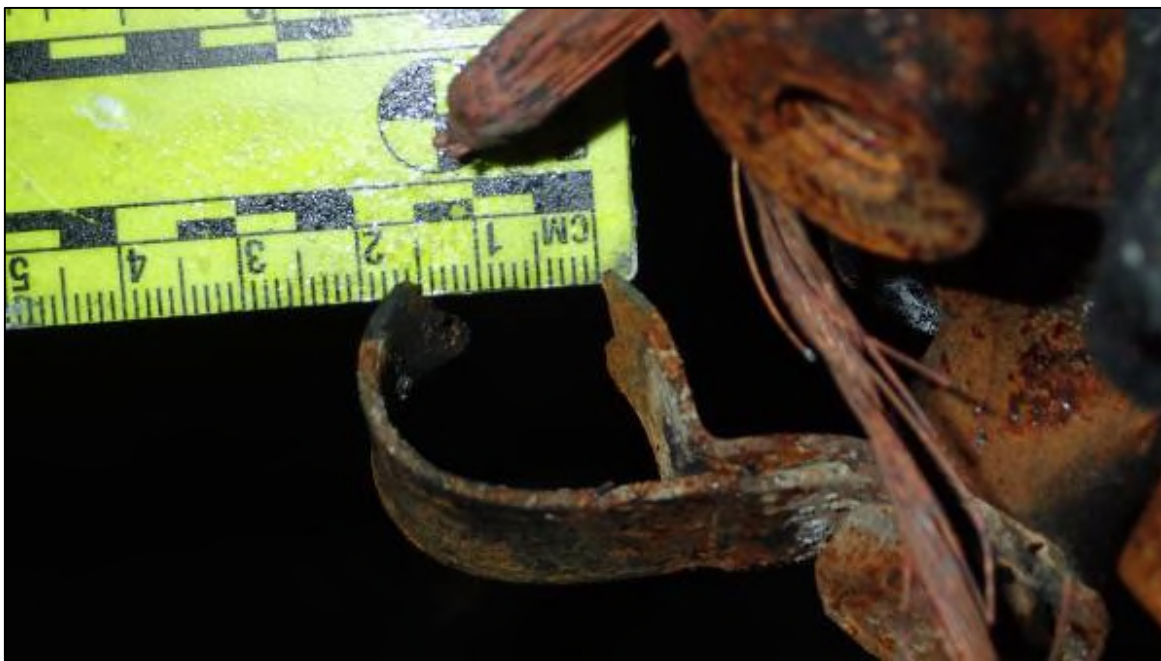
Photograph 4

View of the damaged mount.

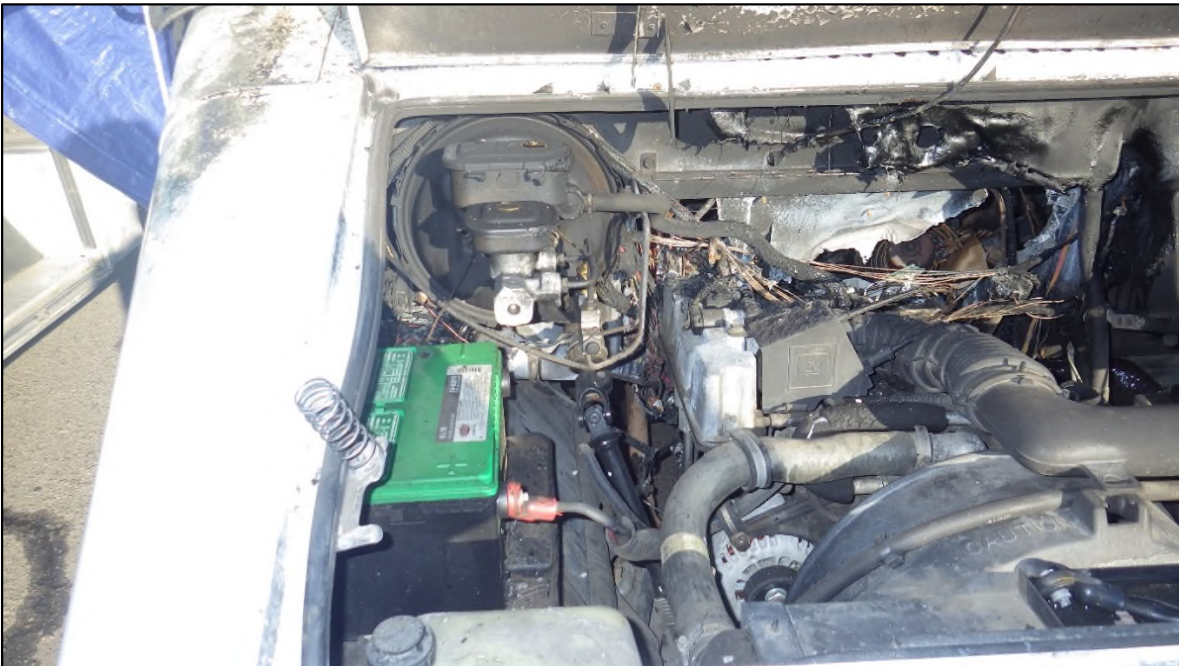
Photograph 6

A view of the battery which was not damaged.

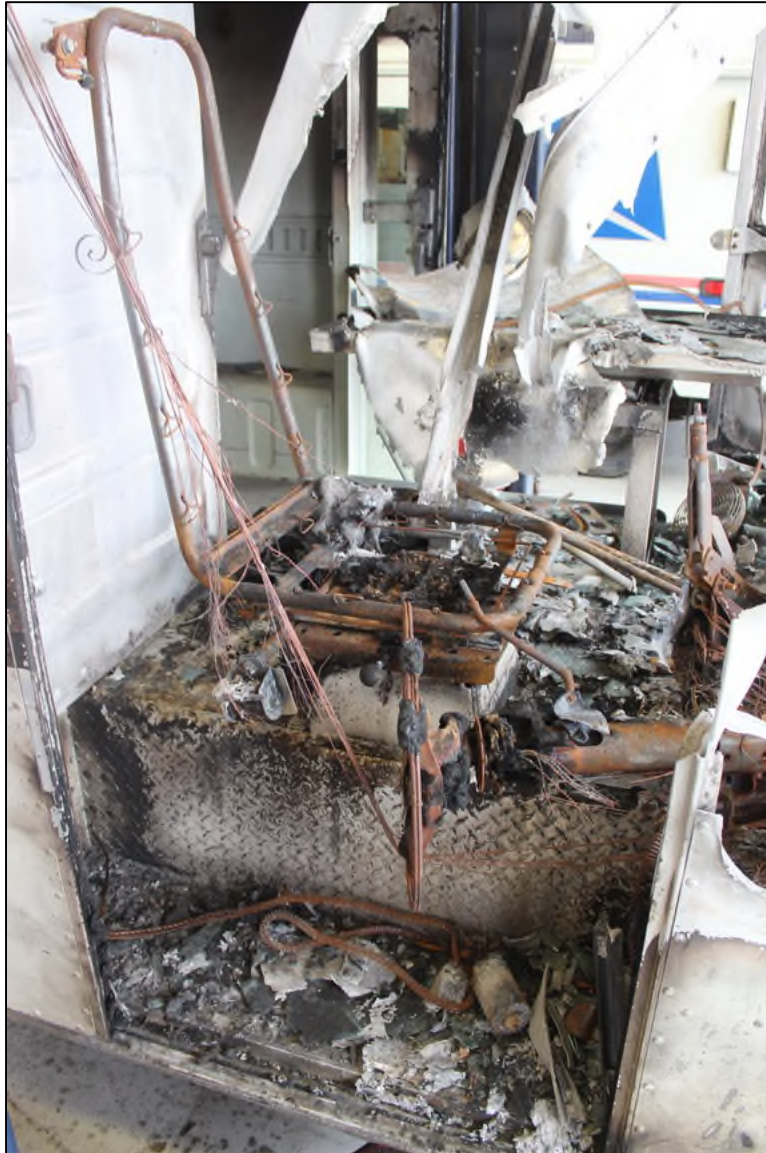
Photograph 3

Fire damage to driver compartment was extension of fire in engine compartment.

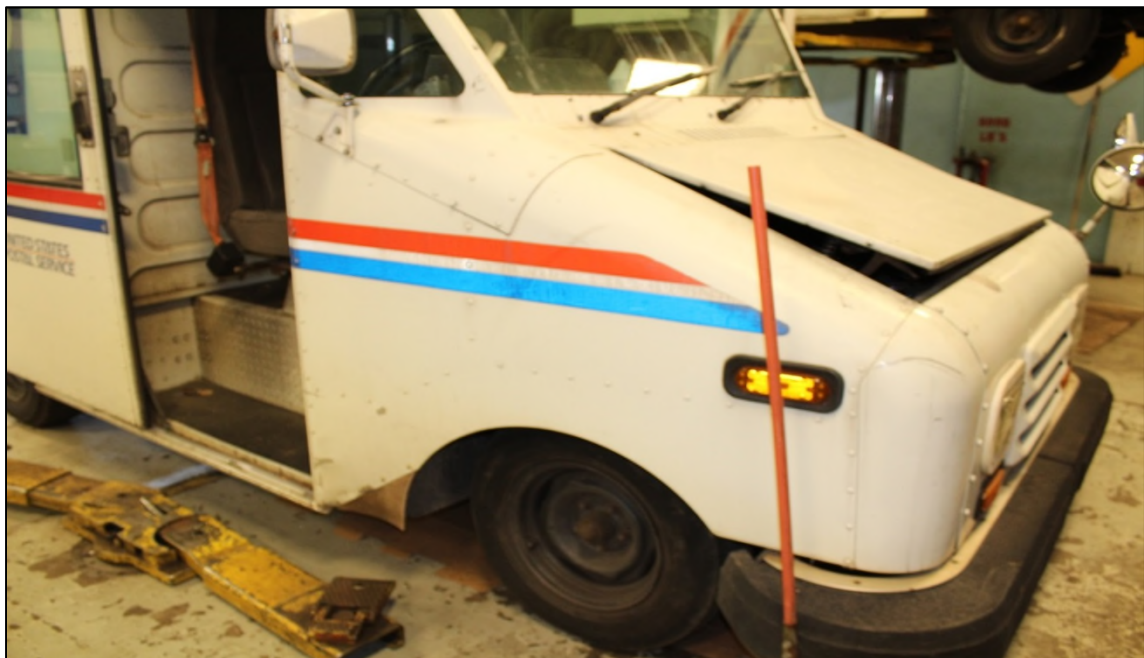
Photograph 2

Observe no fire damage to the exterior of the engine compartment.

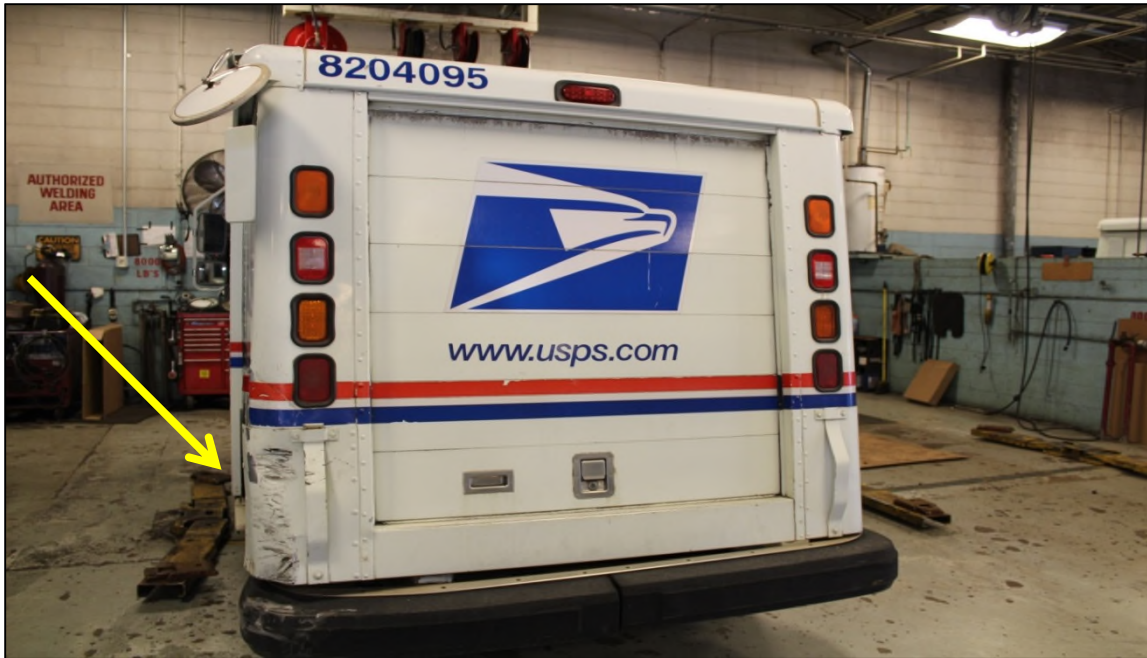
Photograph 3

Rear of the vehicle; observe the minor damage to the left rear corner of the vehicle.

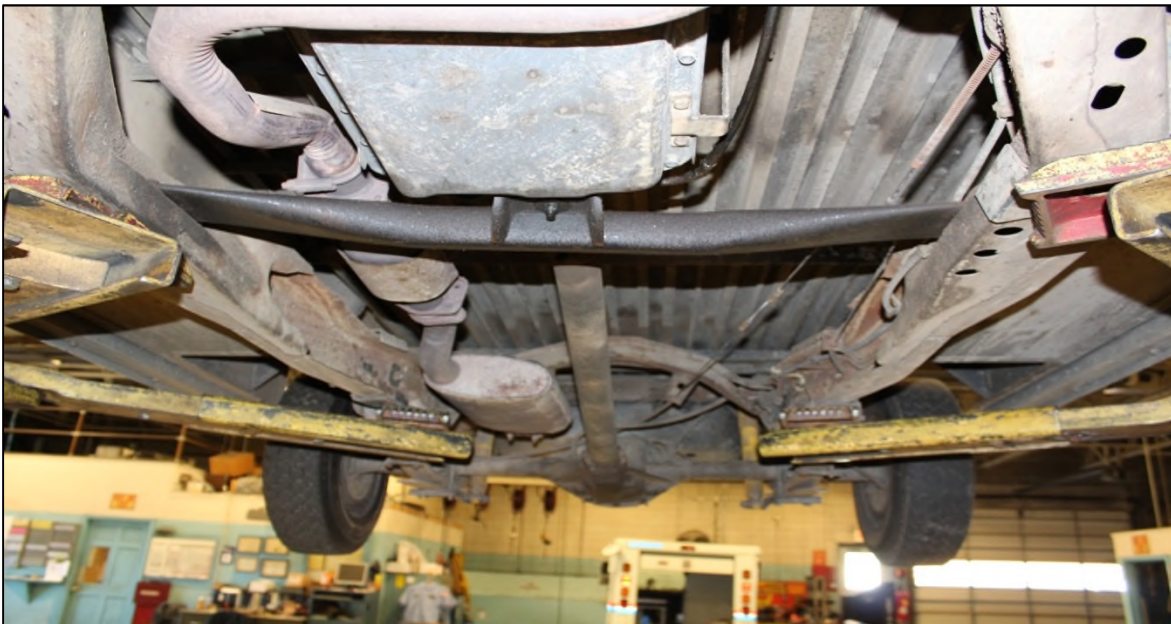
Photograph 4

No damage to the undercarriage of the vehicle.

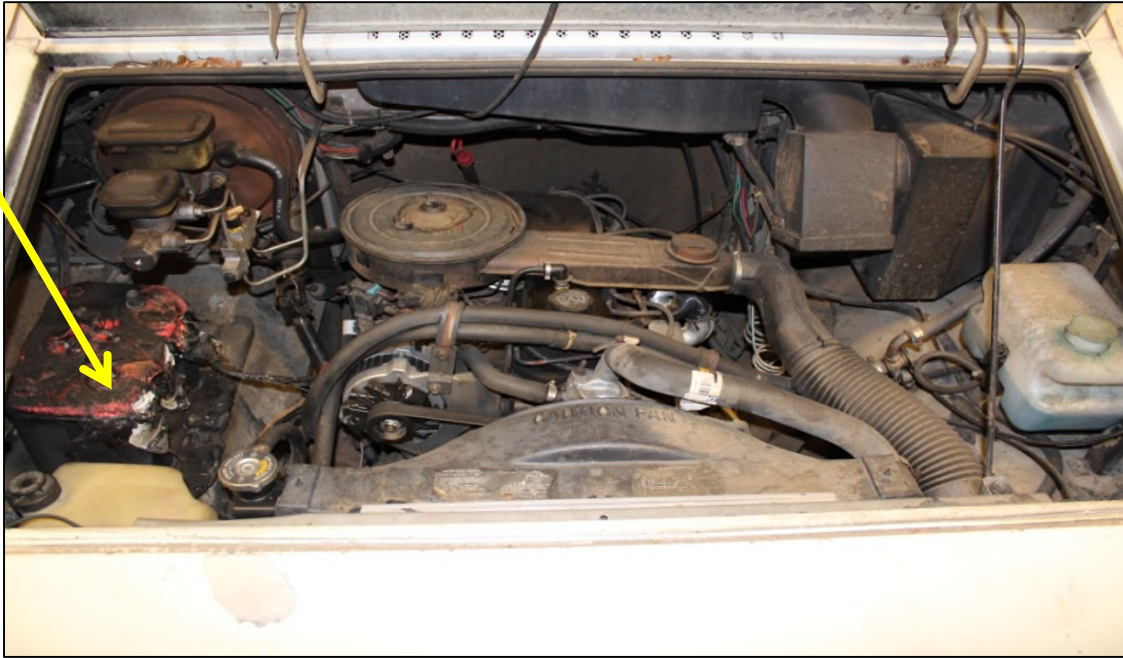
Photograph 7

Engine compartment, observe the damage to the battery area.

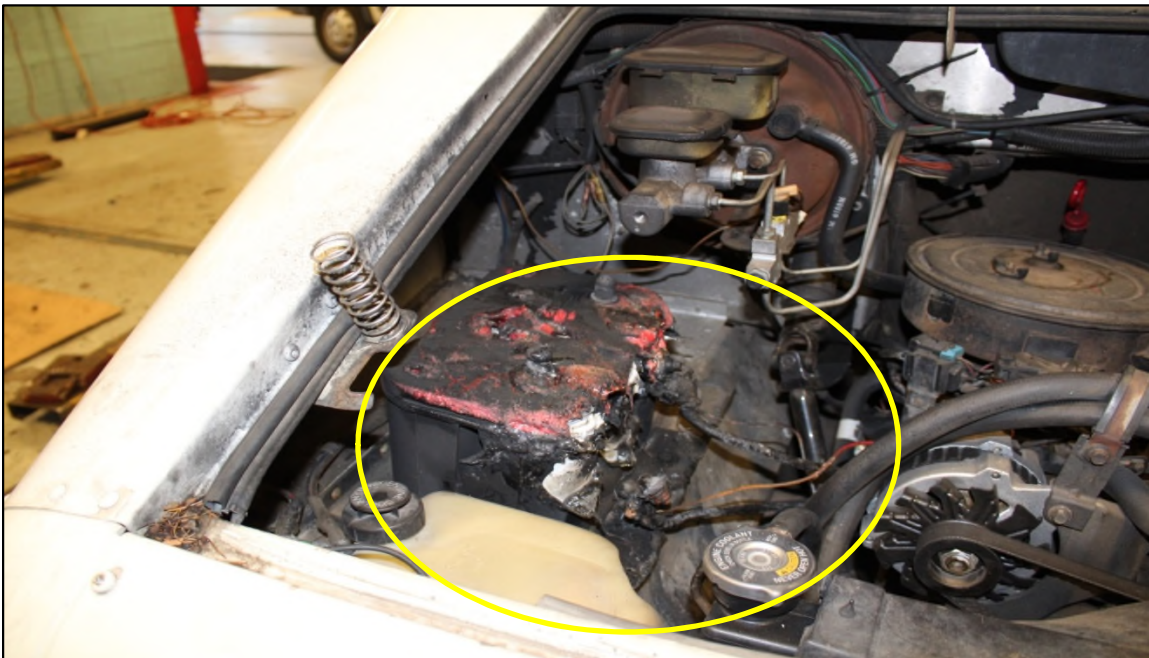
Photograph 8

Observe the damage to the battery terminal area.

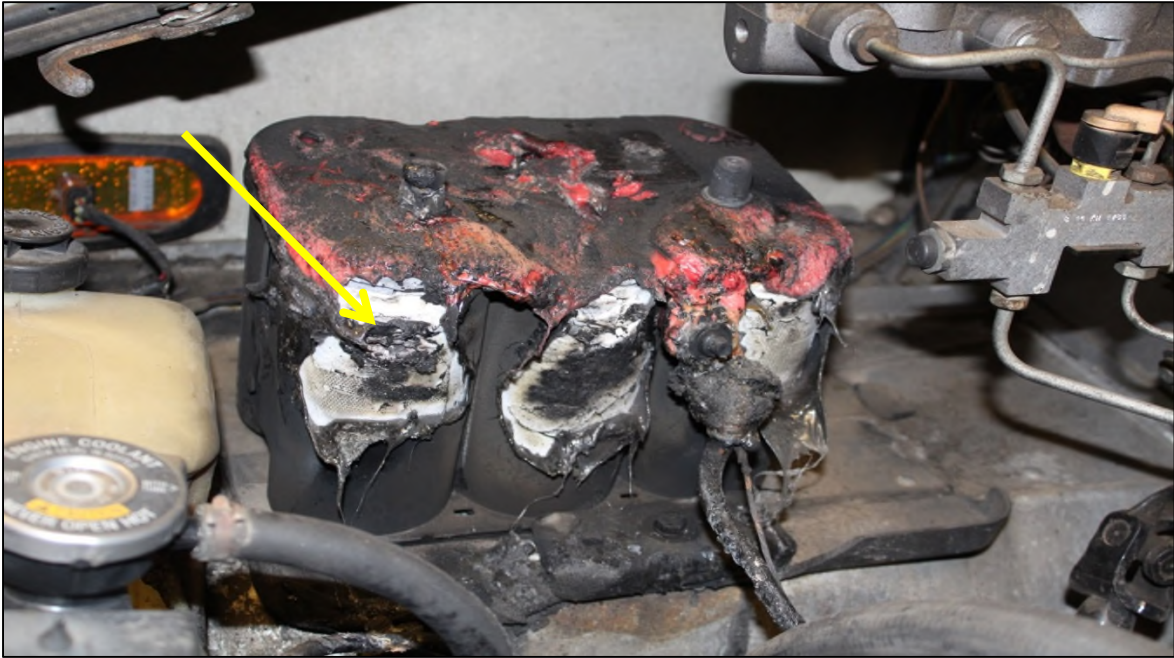
Photograph 9

Observe the most severe damage to the battery terminal area.

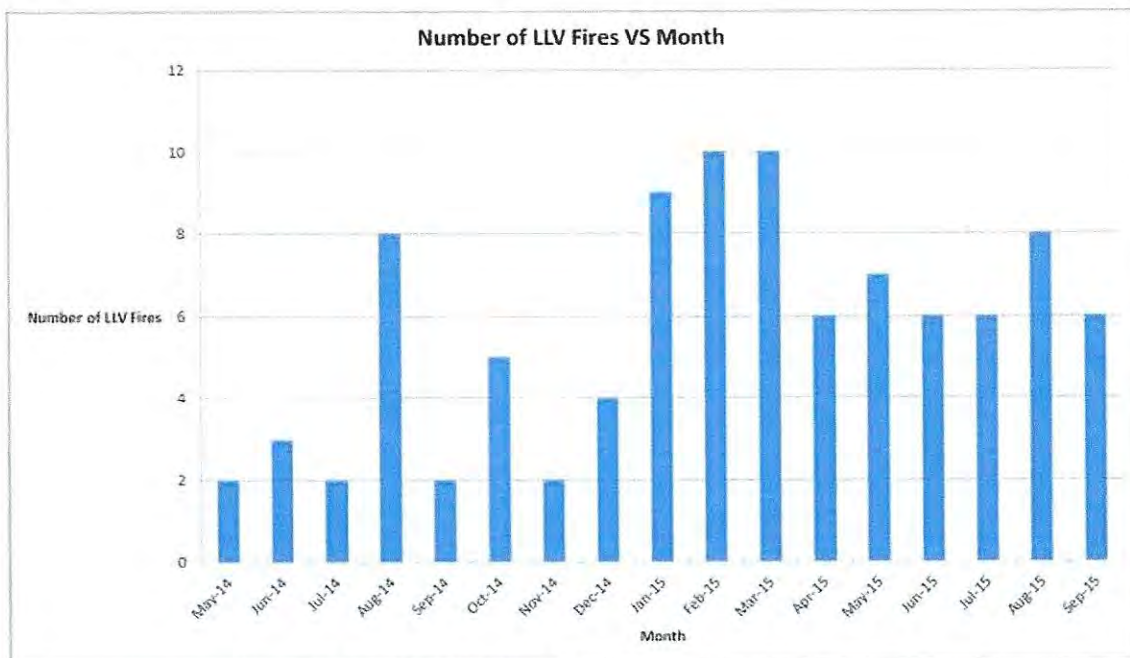
Figure 2. Number of LLV fires by month

These numbers show that the greater number of fires occurred during the months of January, February, March and August of the year. Over the course of the contract, an average of 6 LLV fires occurred each month. The losses during the months of January, February March and August is evidence of the added stress placed on the vehicles electrical system due to extreme heat and cold. This added load can be attributed to the worn and broken down wiring resulting in electrical failures.

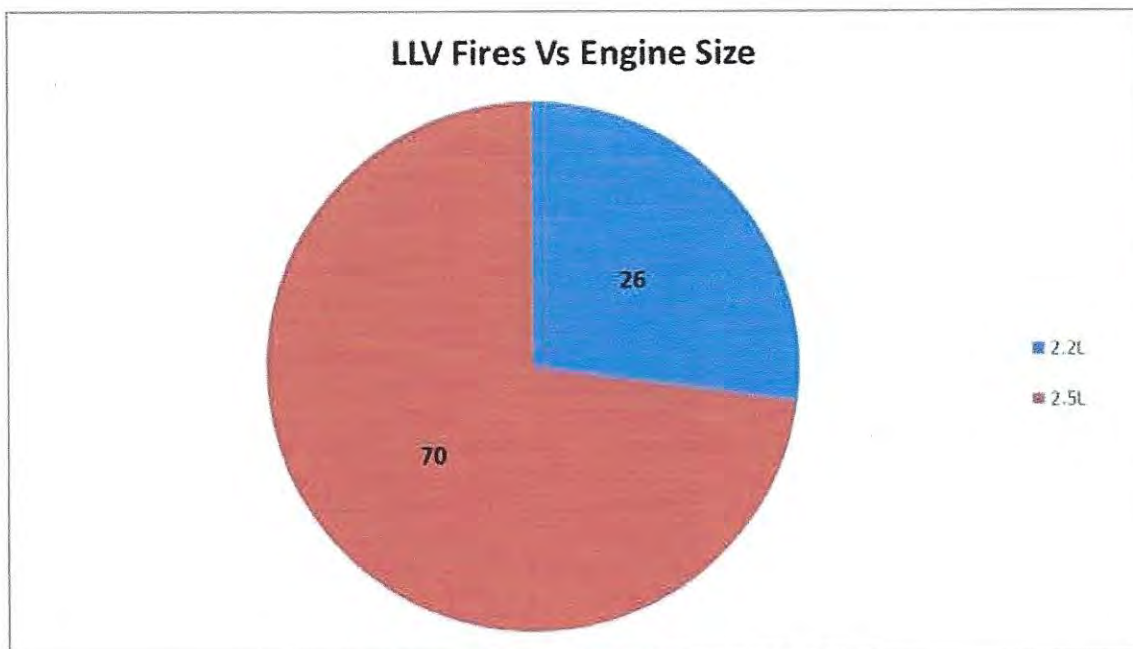
Figure 4 Number of LLV fires by engine size

The 2.2 Liter LLVs had far fewer fires than the 2.5 Liter LLVs. The 2.5 Liter LLVs were introduced in 1987, and the 2.2 Liter LLVs were introduced in 1994. The majority of the 2.5 Liter LLV fires were electrical in nature again leading to the problem of worn out electrical systems.
